**North Park Branch Library  
235 Delaware Ave  
Buffalo, New York**

## **Building Evaluation Report**

Buffalo & Erie County Public Library  
1 Lafayette Square  
Buffalo, NY 14203

August 15, 2008

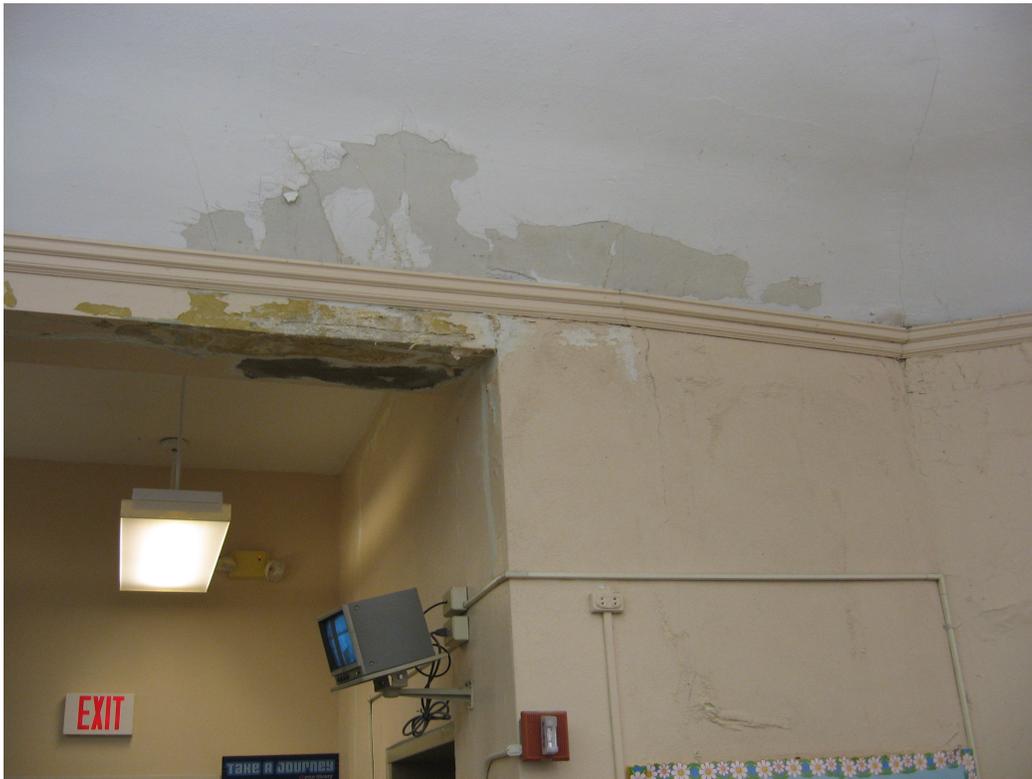
Photo 1: Water damage has caused lead-based paint (LBP) and plaster above circulation desk area to deteriorate.

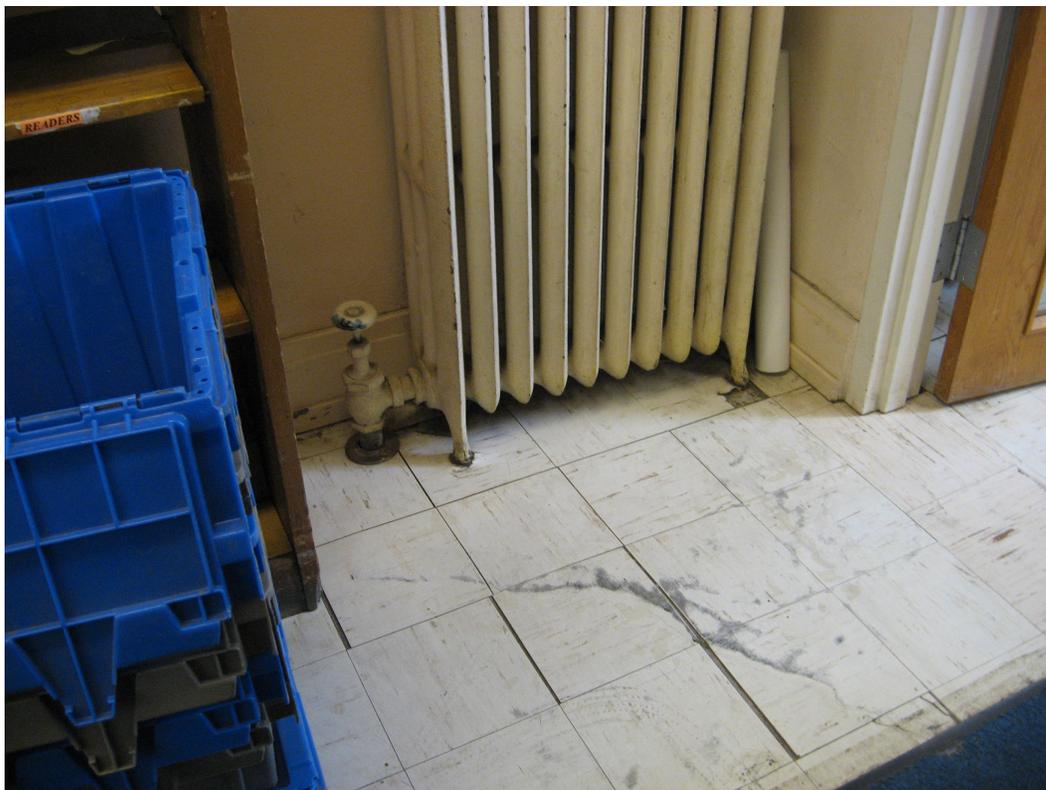
below this location. The concrete floor behind the reference desk, at the entrance to the office, has cracked and the floor has heaved.

Photo 2: Asbestos containing tile (ACT) shown over apparent floor cracking outside of office area.

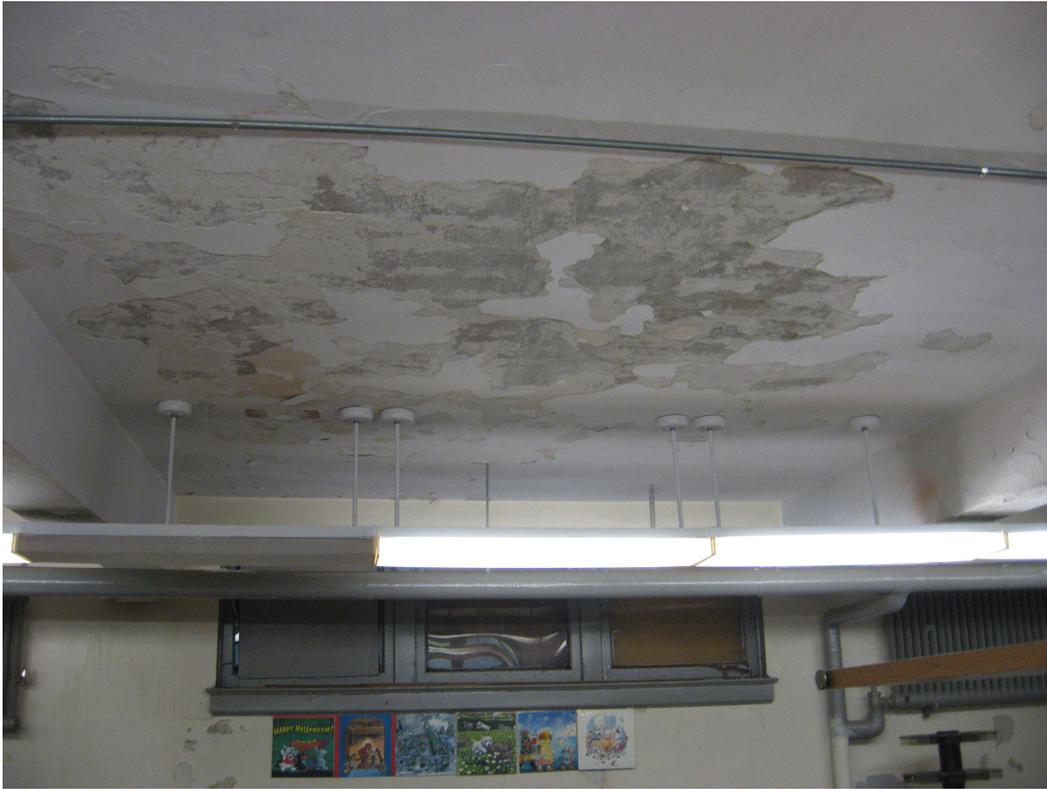
The walls and ceilings throughout the building are coated with LBP. The LBP in the basement Conference Room is in poor condition (i.e., blistering and peeling). Complicating the condition of the paint is the deteriorating condition of the plaster walls and ceilings in this area. These conditions also exist on the first floor with respect to the walls. The ceiling paint on the first floor is in poor condition but the plaster appears to be intact.

Photo 3: Damaged ceiling in basement meeting room. Lead based paint and plaster are falling.

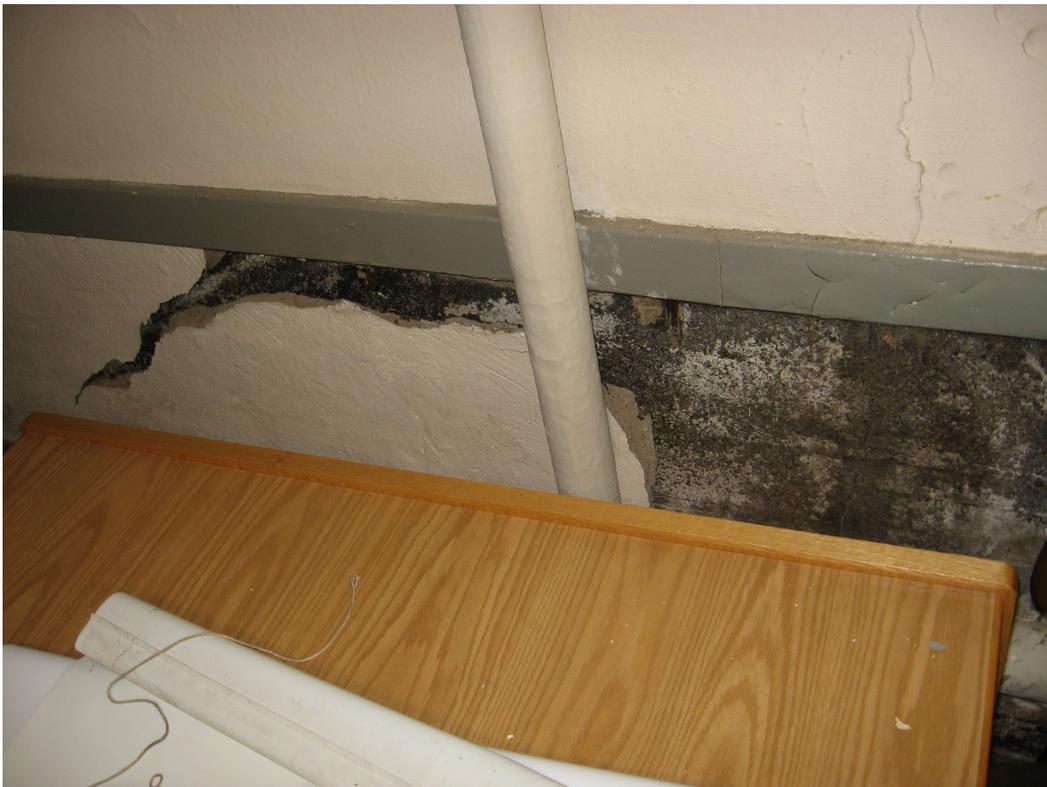
The cracks throughout the foundation wall have been measured and noted on the existing conditions survey included in Appendix A. In many locations the cracks are the full height of the foundation wall and are leaking water into the basement. The water leaching through these cracks is being trapped behind the plaster on the wall causing the plaster to separate from the foundation wall. In some locations the plaster has fallen off the wall and mold has been observed growing on the foundation wall. About 75% of the plaster in the large conference room of the basement is separating from the wall. Approximately 50% of the south wall of the room adjacent the stairway has plaster that is hollow sounding, possibly indicating separation from the wall. The exterior wall of the lavatory has mold appearing on it which likely indicates constant moisture.

Photo 4: Water damage to basement walls have caused plaster and lead based paint to deteriorate. Foundation walls are also cracking at numerous locations.

Cracks in the foundation walls should be repaired to prevent water from infiltrating into the building and help prevent further cracking of the masonry. Repair of the cracks can be accomplished by epoxy or urethane injection into the cracks from the interior of the building. All hollow sounding, loose and fallen plaster must first be removed from the foundation wall and the vicinity of the foundation cracks. The cracks then need to be cleaned out and injected with epoxy

or urethane. Any cracks which can not be filled from the basement need to be filled from the exterior of the building.

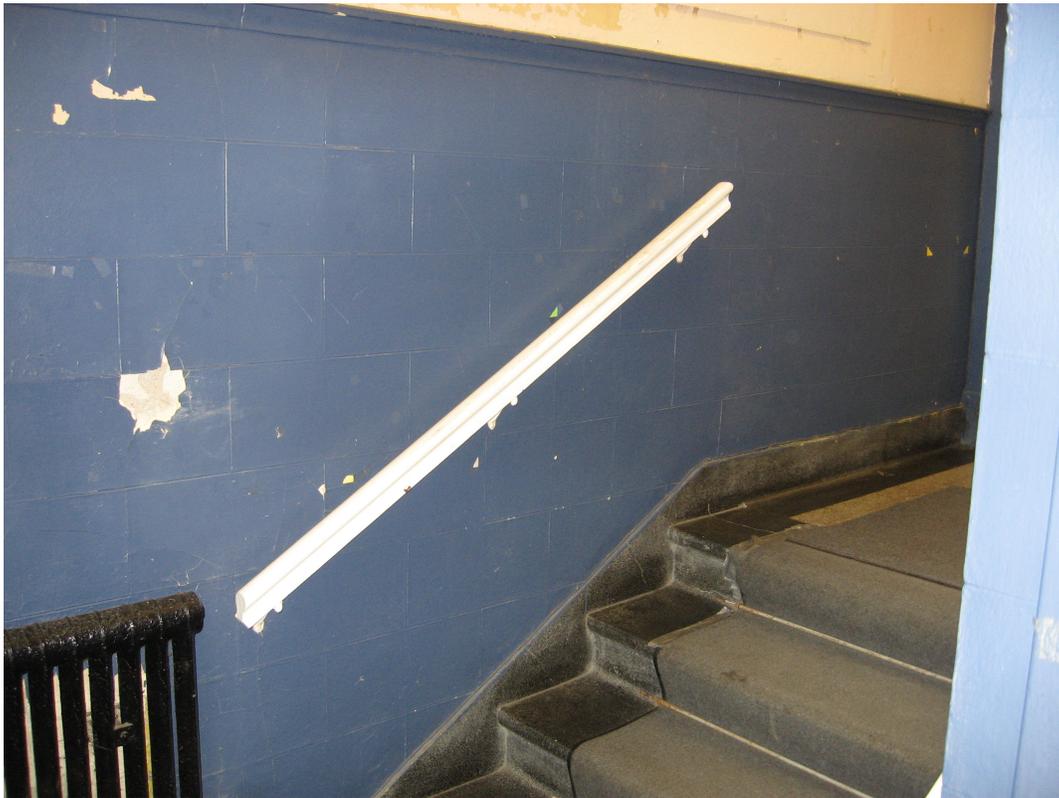
Photo 5: Front stair handrail and chipping paint.

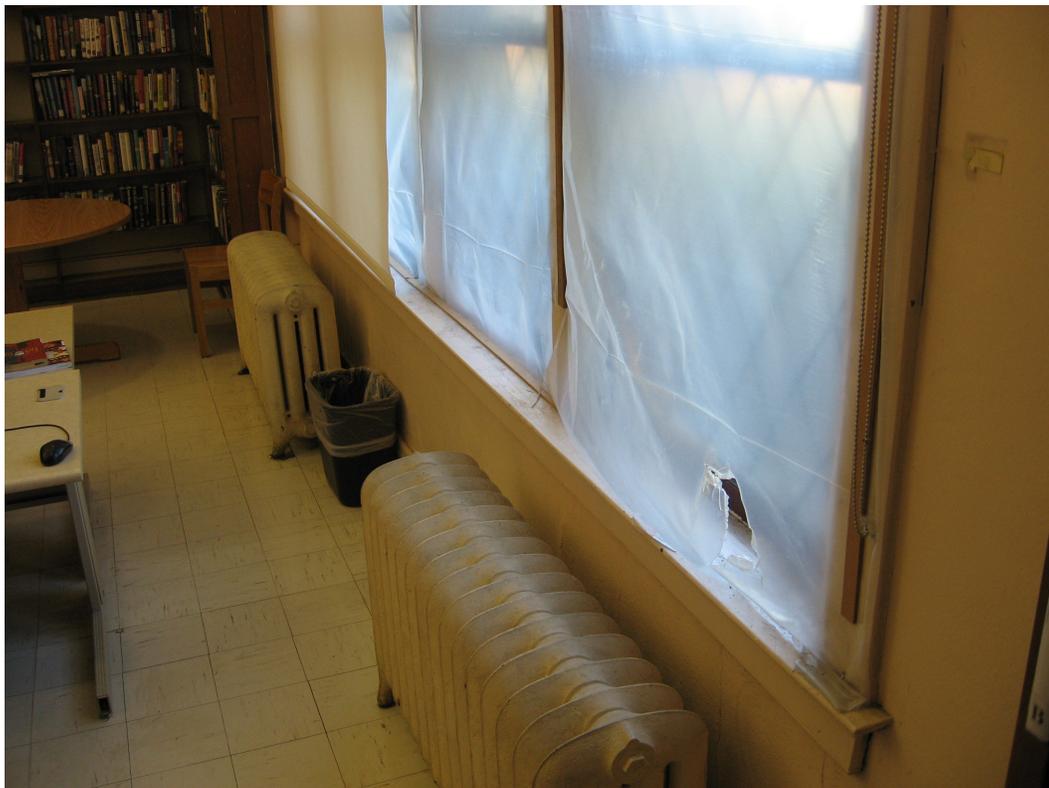
It has also been reported that the area around all of the door and window frames are poorly sealed, allowing for air infiltration during all seasons.

Photo 6: Single pane windows covered with plastic throughout the building.

To insulate the windows, all single glazed windows will need to be replaced with double glazed (insulated) glass panes. All of the windows in the basement will also need double glazed glass panes. Security glass is recommended if vandalism is a problem. All window frames and sashes throughout the building should also be restored or replaced in order to eliminate areas of air infiltration as well as to accommodate the thicker, double glazed panes as required. All counterbalancing, hinges, handles and other operational hardware will need to be restored or replaced in order to return the windows to an operable state. In addition, all areas of plaster damage on the ceilings will need to be patched. Also, walls where lead paint is being removed will need to be furred-out with gypsum plaster boards. The conference room in the basement will require a new drop ceiling, and the majority of the basement will require new VCT flooring to replace removed tiles found to be asbestos containing. All areas of repair and new construction will require paint. Areas of graffiti on the exterior of the building will also require masonry cleaning.

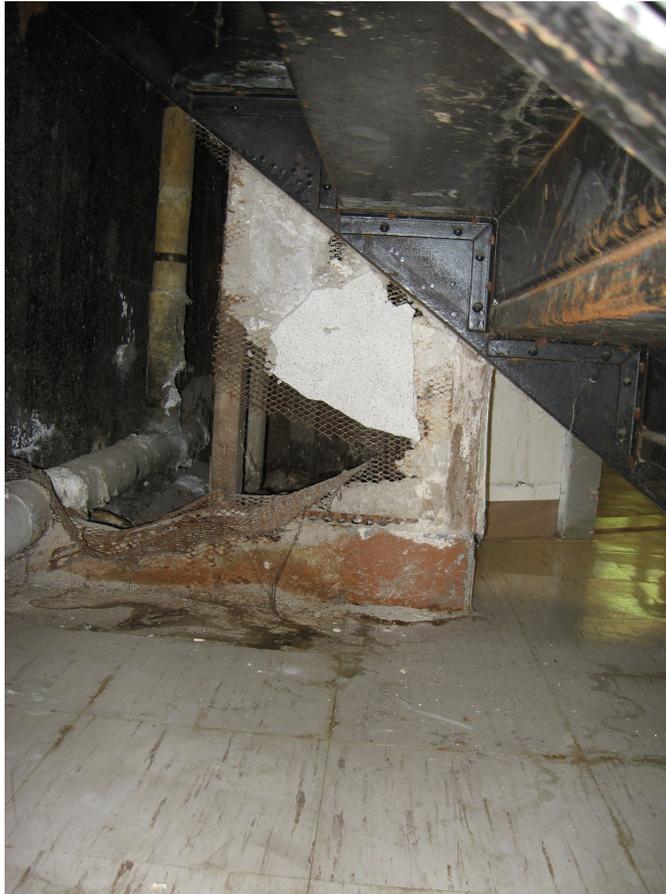
Photo 7: Damaged chase wall in basement below front stairs. Also shown are VCT tiles located on the basement floor.

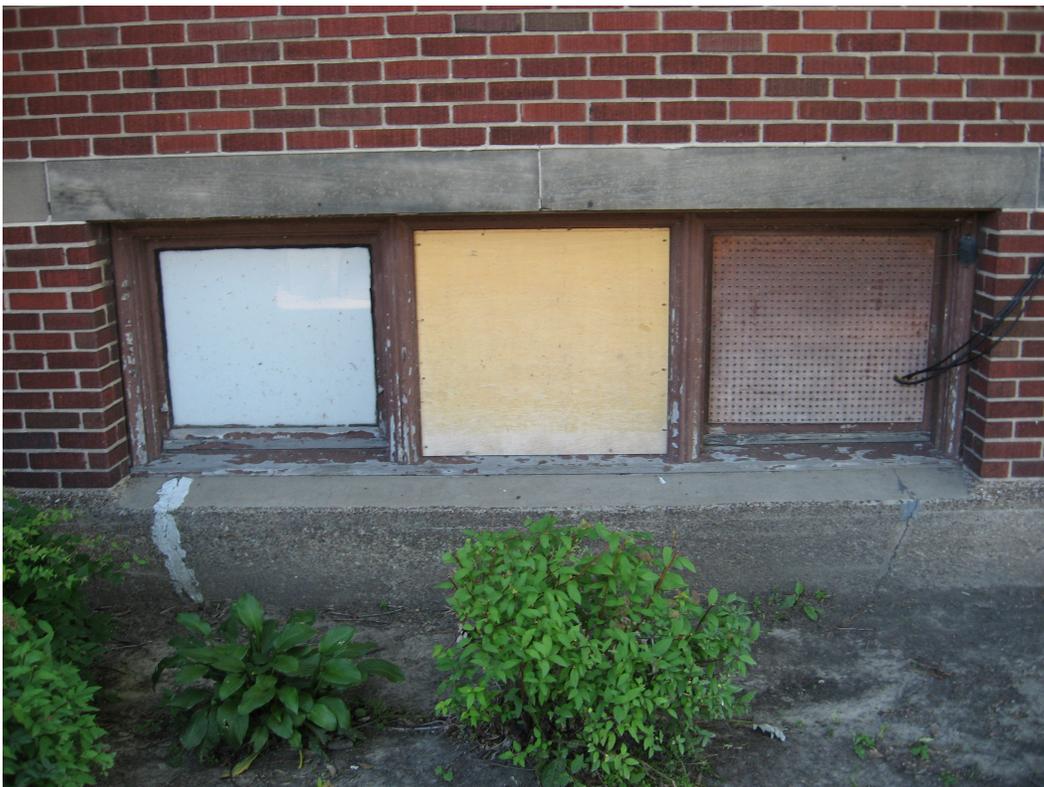
Photo 8: Various windows replaced with plywood or peg-board. Shown is the basement window of the boiler room.

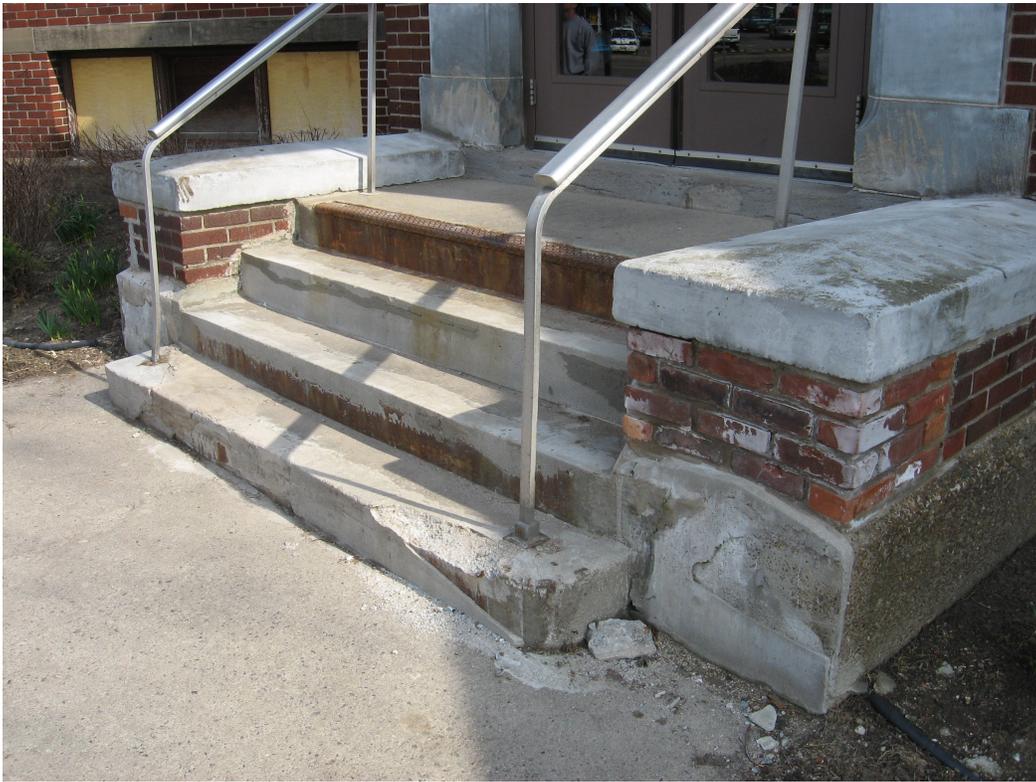
In addition to the cracked and spalling condition of the exterior stairs, the stairs themselves are not up to New York State Building Code in terms of required rise and run of each step. The existing metal handrails of the exterior stairs and the handrail of the interior stairs leading to the main room of the library are also not up to code.

The masonry, treads, and risers of the exterior stairs have been previously repaired. At present the treads are spalling and are in need of repair. The lintel above the exterior door into the exit stairway of the large conference room in the basement has a lintel that is “rust jacking” (i.e., heaving due to rust formation on the steel surface) and causing the existing brick above and adjacent the door to heave and crack.

Photo 9: Front entrance stairs showing non-code compliant handrails and step damage.

In order to satisfy the requirements of the building code, the exterior stairs will need to be demolished and completely rebuilt with an acceptably designed rise and run. The new stairs will also require new metal hand rails of the correct height, diameter and extension at top and bottom to meet code. The interior handrail will also need to be replaced with a handrail of the correct diameter

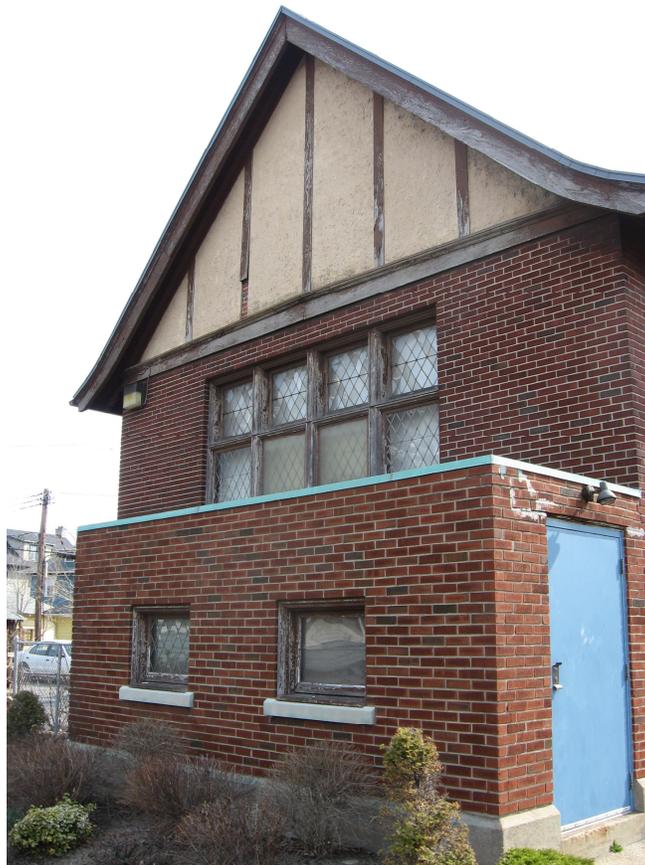
Photo 10: West end of building exterior showing stairwell entrance that will be used to house proposed ventilation air units. Note the poor conditions of the fascia board and window frames.

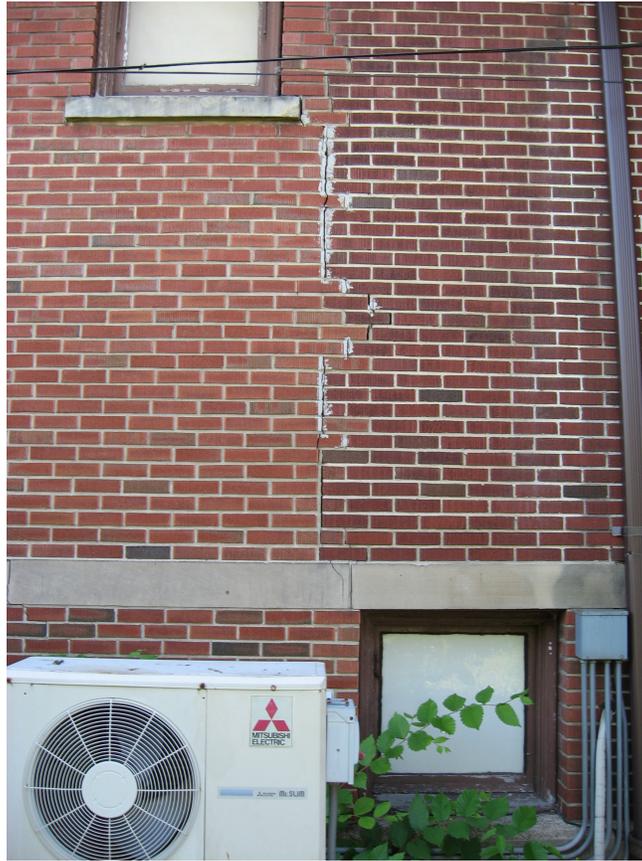
The one story addition on the north east corner of the building has settled resulting in step cracking in exterior brick walls and a crack in the foundation wall directly

Photo 11: North wall at building addition showing cracking and boarded basement window. Note the peeling paint and poor condition of the window frames.

The foundation repairs for the settled building addition can be accomplished using epoxy or urethane injection but will need to be done from the exterior of the building. The brick will need to be repointed and cracked or broken bricks replaced. The cracked and heaved floor on the interior of the building at this location needs special consideration. The flooring in this area will need to be removed in addition a radiator will need to be temporarily displaced. Upon completing these tasks a portion of the concrete floor will need to be removed and then recast to adjust for the elevation difference between the addition and the main building.

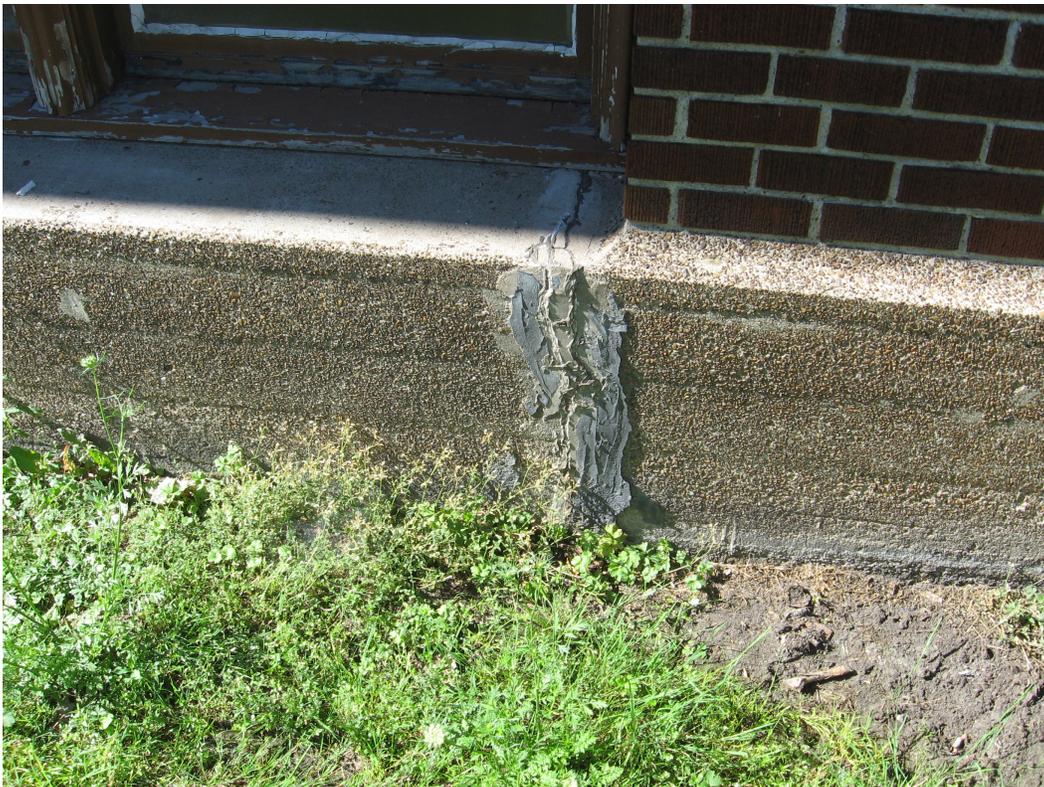
Photo 12: Foundation wall cracking that was previously repaired and poor condition of window frames.

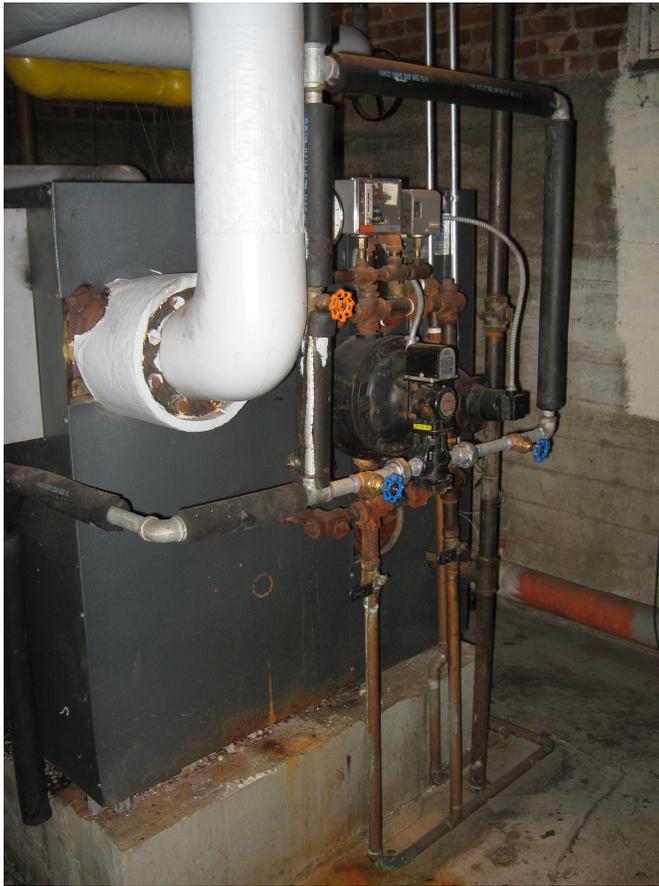
The boiler is a Weil-McLain low pressure (15 psi), gas fired, natural draft, 7 section cast-iron boiler. The gas input is 780 MBH and the output is 631 MBH. The boiler is approximately 20 years old and is approaching the end of its useful life. The cast iron radiators and steam supply and condensate return piping appear to be in good condition, however these items have far exceeded their useful life. The age and visible condition of the system lends us to believe that there is internal pipe corrosion.

Photo 13: Existing Weil-McLain steam boiler.

Our recommendation is to provide a condensing, high efficiency gas fired boiler.

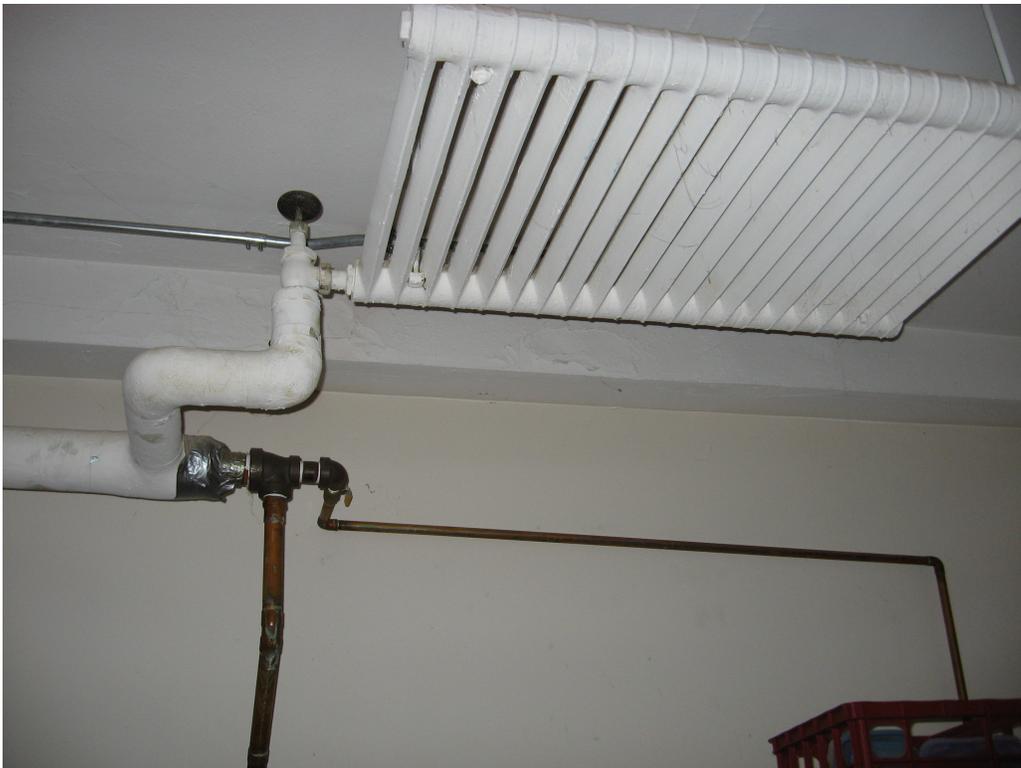
Photo 14: Steam radiators mounted in the horizontal position near the ceiling in the basement.

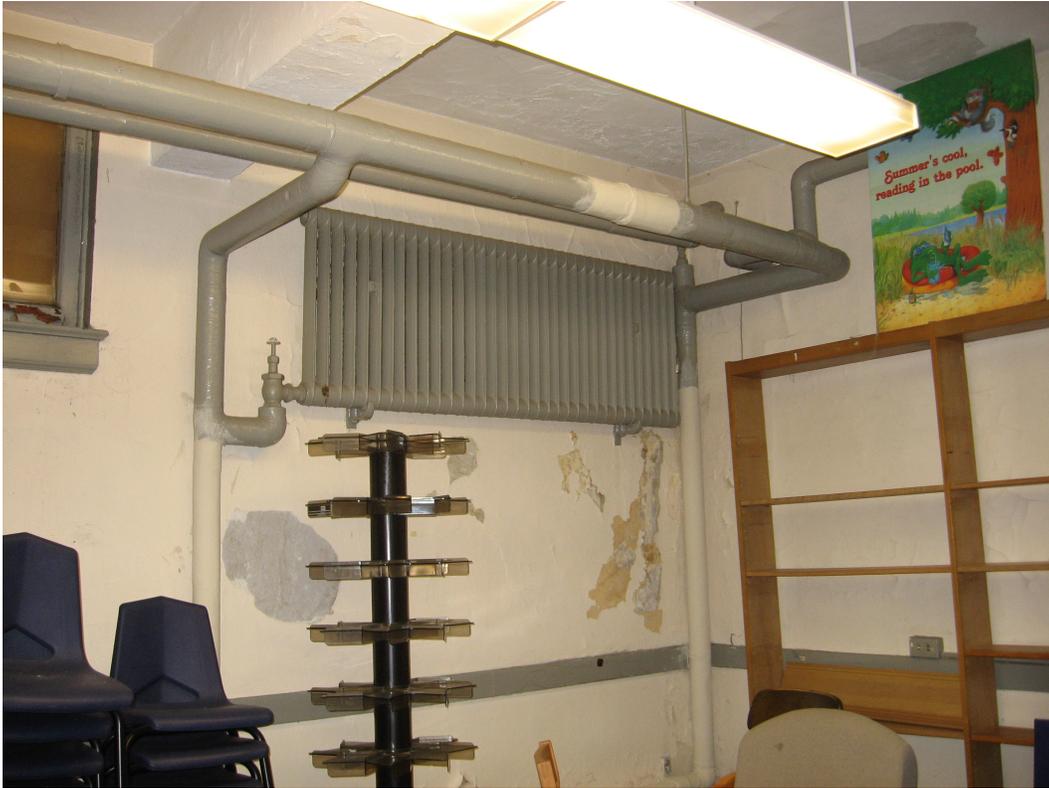
Photo 15: Wall mounted steam radiator located in the basement meeting room. Note the poor wall conditions as well as the boarded window and deteriorating frame.

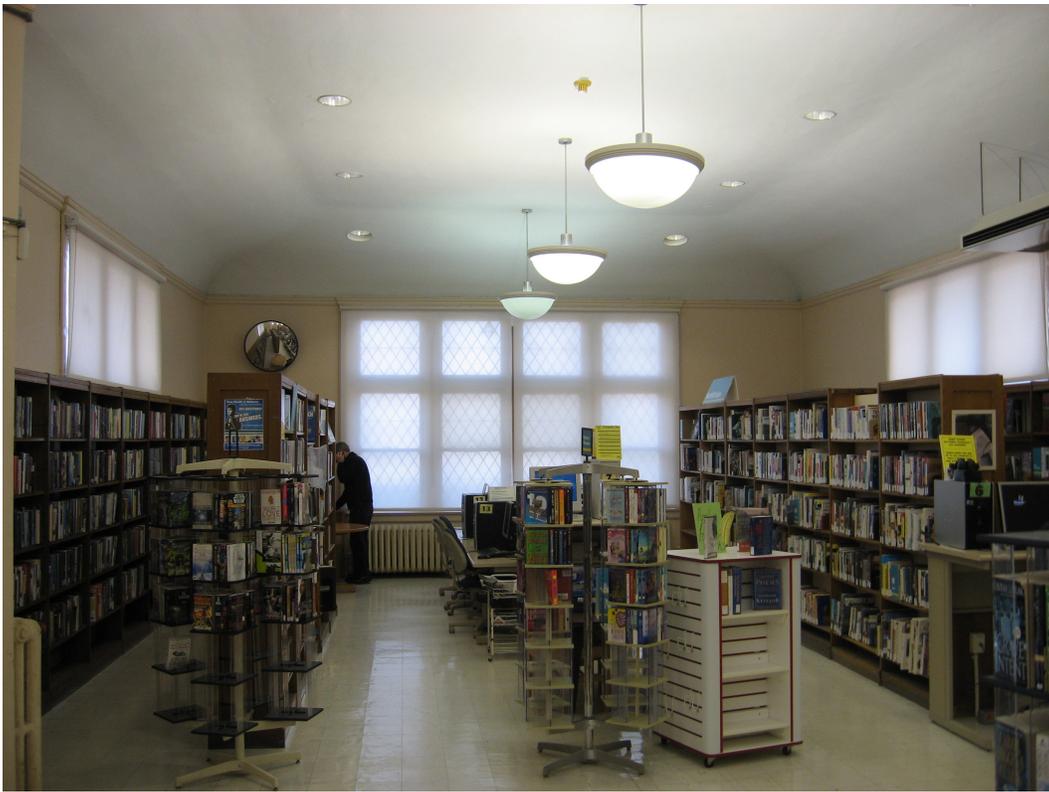
Photo 16: North wing of library showing steam radiators, plastic over windows and ceiling hung air conditioning split system.

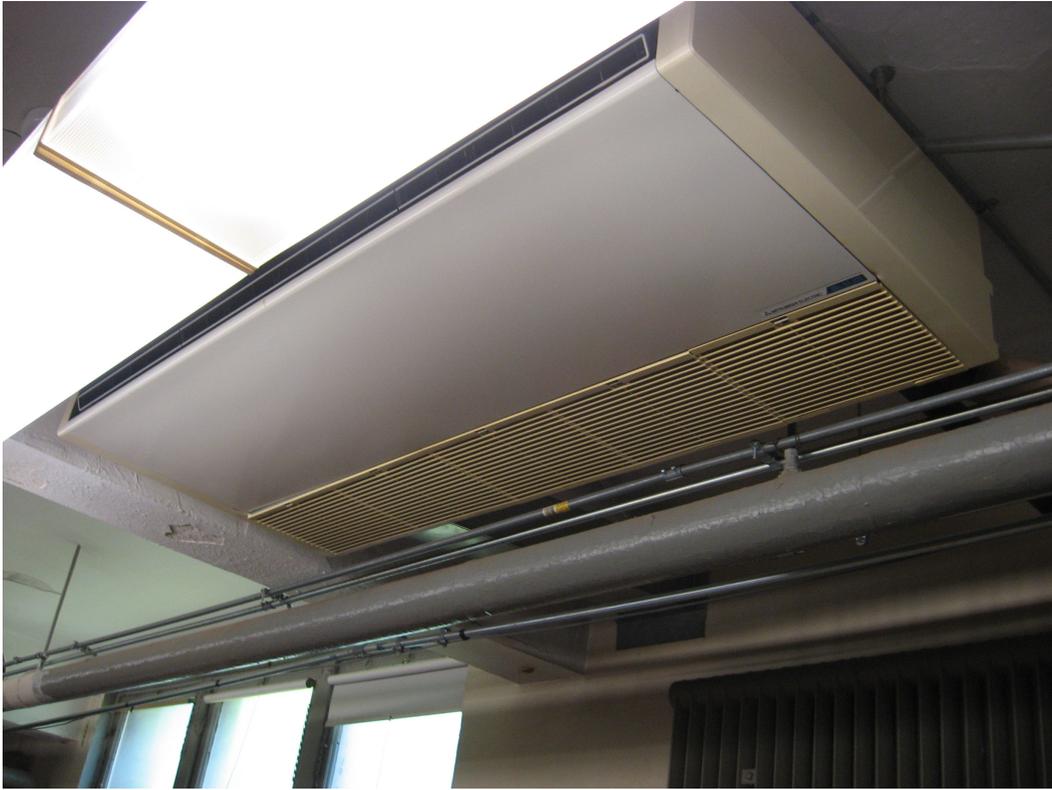
Photo 17: Ceiling mounted air conditioning split system located in the basement meeting room. Unit isn't supplying the code required ventilation rate.

We recommend Option #2 for providing air conditioning and ventilation for the spaces.

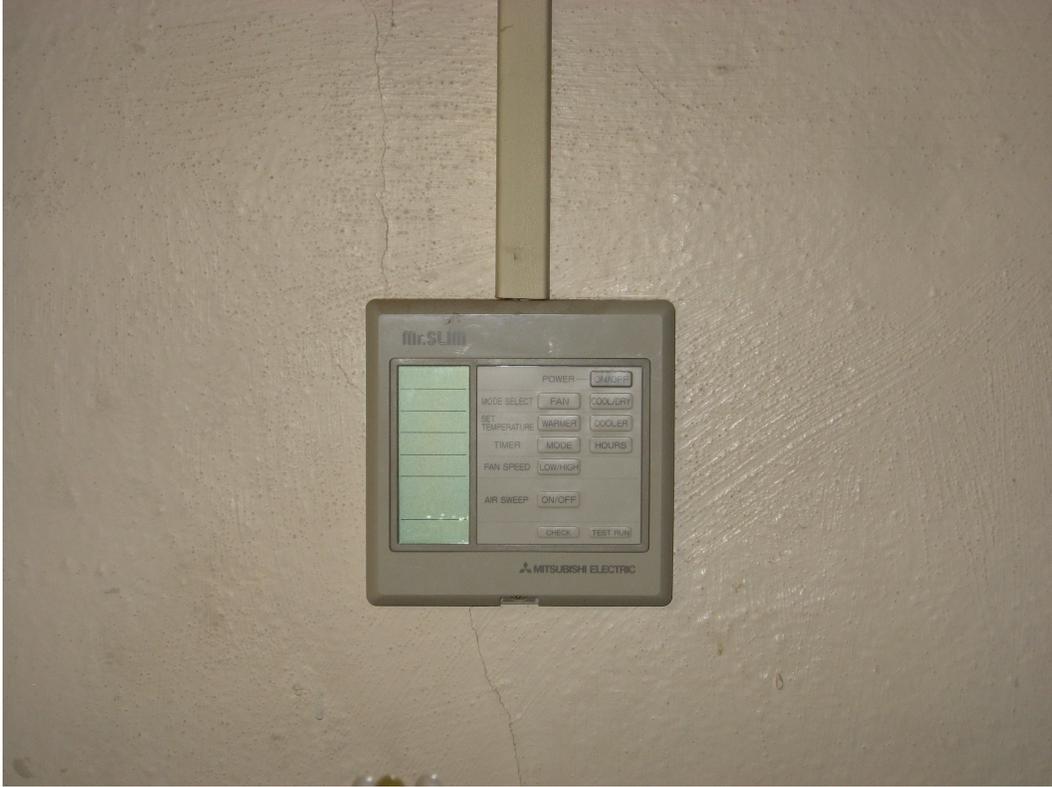
Photo 18: Control for split systems. This is typical of ceiling hung units, one in basement meeting room and one in the library area controlling both units on the main floor.

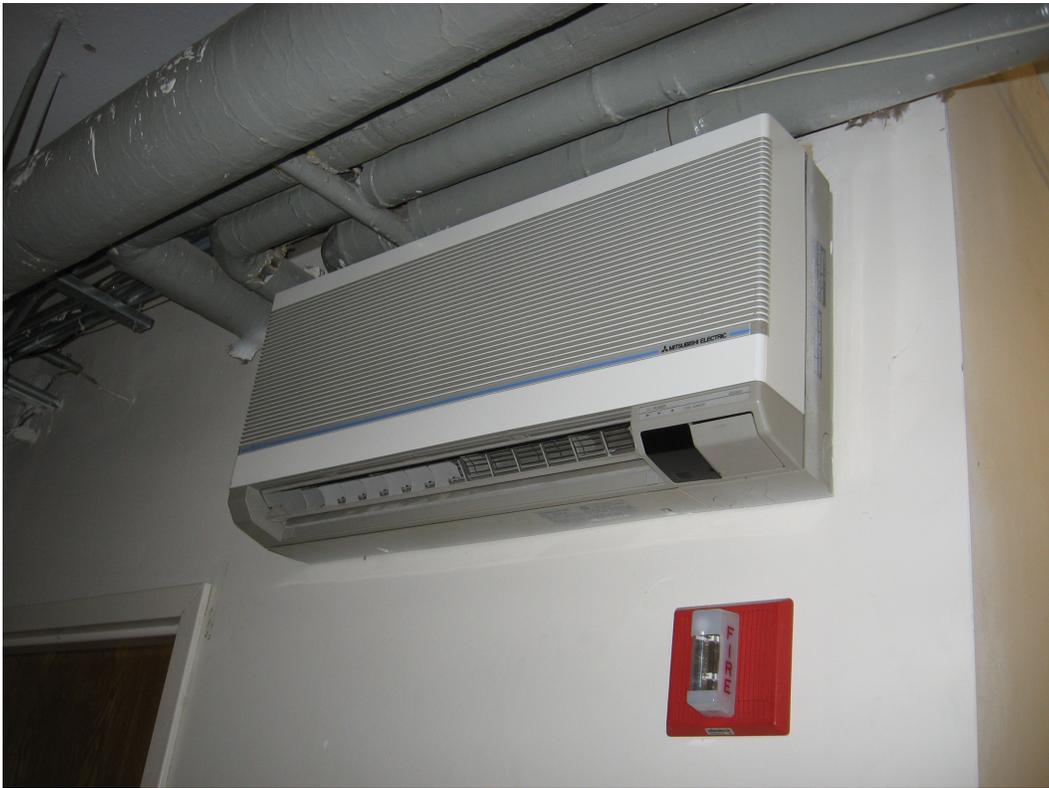
Photo 19: Wall hung split system in basement corridor area.

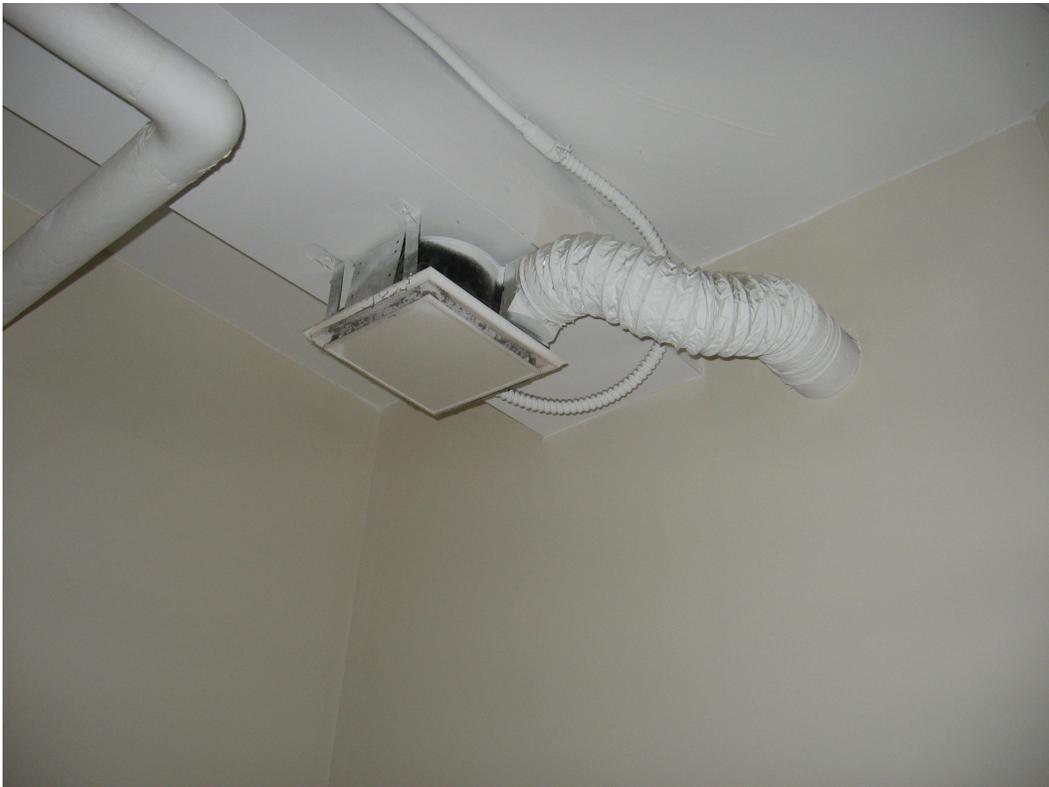
Exhaust fans are located in each toilet room and exit to the back of the building. They appear to be in fair condition.

Photo20: Typical exhaust fan for each basement restroom.

The restroom ventilation is in fair, working condition, but has been painted. The fans and grille could be cleaned while the flex duct needs to be replaced due to age. It would be recommended that both exhaust fans also be replaced

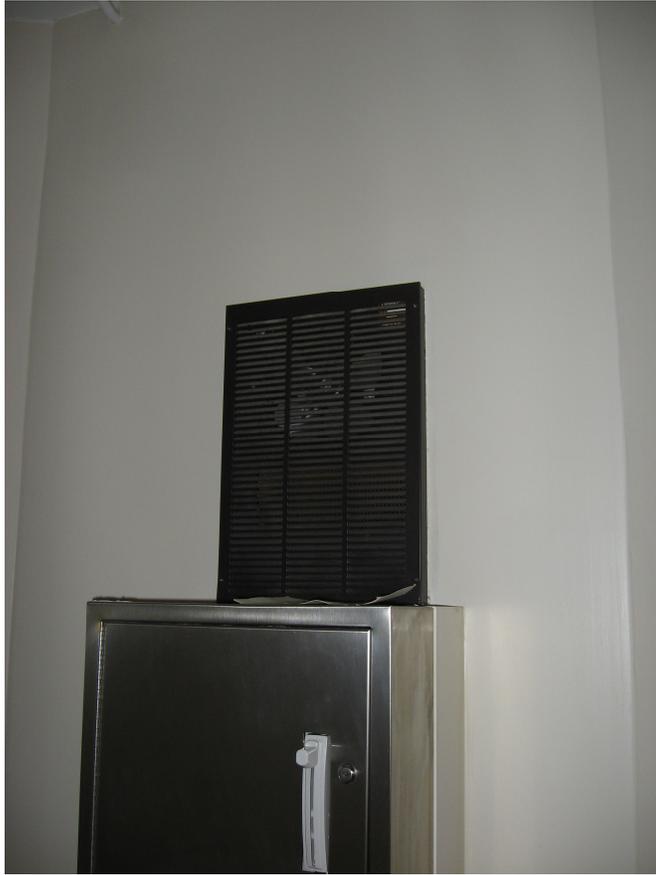
Wall mounted electric heaters are located in each of the basement restrooms, as well as at the bottom of the rear stairs. The restrooms have 1500W units while the stair is served with a 1000W unit. These all are in fair, working condition and we would recommend their continuation of use.

Photo 21: Wall mounted electric heater typical of both restrooms and bottom of stairs in rear stairwell.

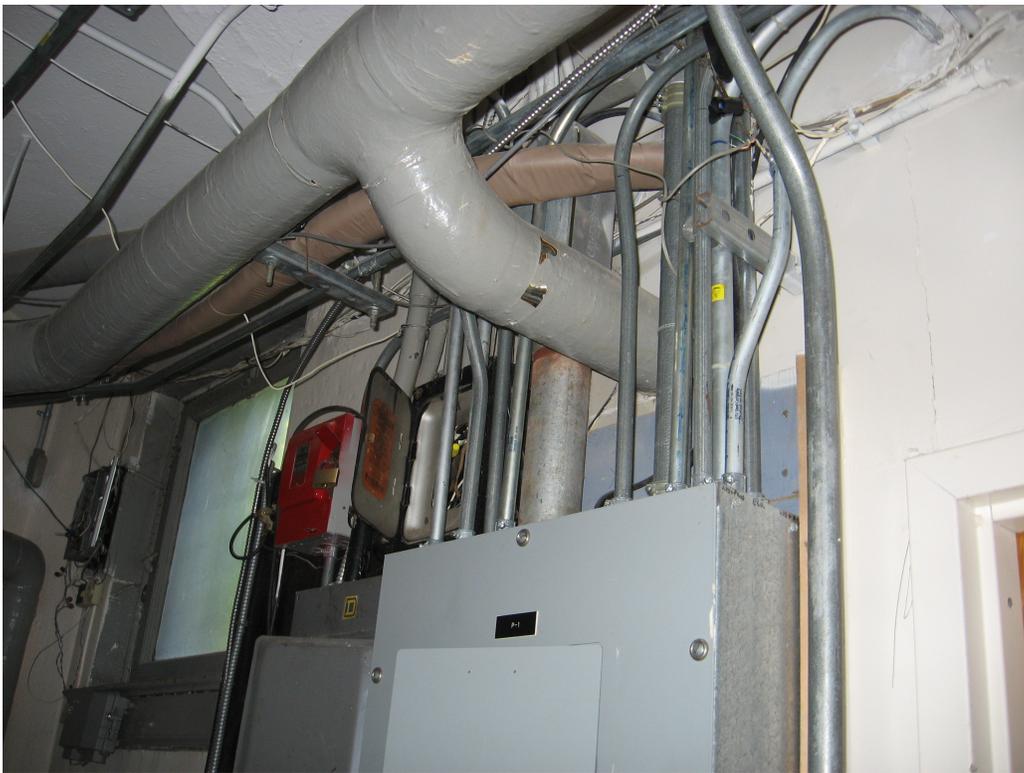
Photo22: Basement electrical panels with steam and refrigerant piping routed directly over panels.
